Manhole Inspection Summary

Manhole # S49AA_018MH

Insp Date: **5/8/08 10:35 AM**

Location Address: **611 n lakewood ave**

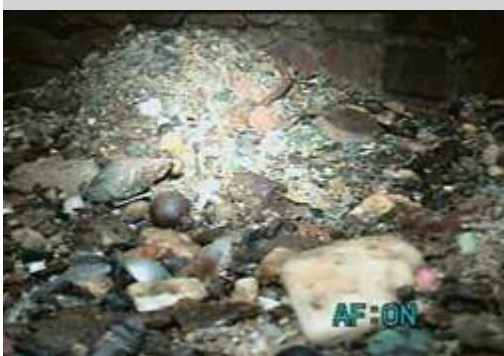
Defect 3

Condition: ☐ Sound ☐ Cracked ☐ Root Intrusion ☐ Deteriorated ☐ Leaks ☒ **Debris**

bench debris

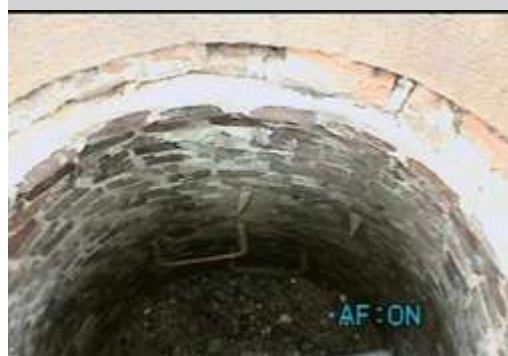
Defect 2

Count: **4** Missing: **2** ☒ **Corroded**

steps

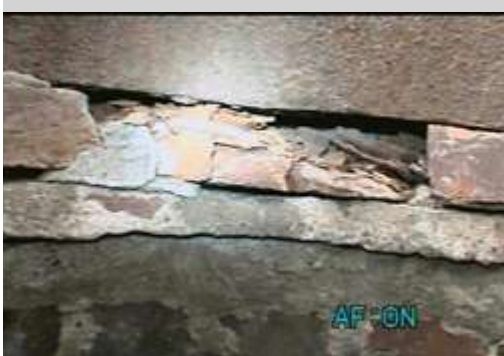
Defect 1

Condition: ☐ Sound ☐ Cracked ☐ Root Intrusion ☐ Loose Brick ☒ **Deteriorated**

chimney_cond_deteriorated

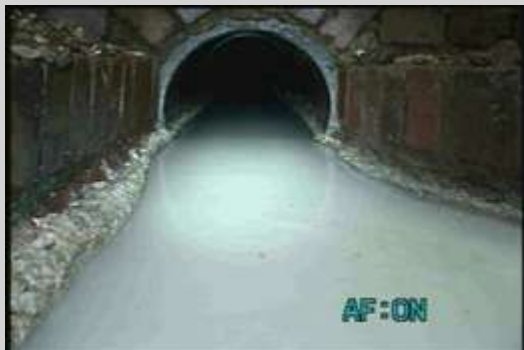
12 O'Clock Outflow

10 in. Circular Gravity Sewer
Pipe Out @ 12 O'Clock

Invert Depth: **9.18** (ft.) Flow Characteristics: **Fast**

Infiltration: **None** Pipe Seal Cond: **Unknown**

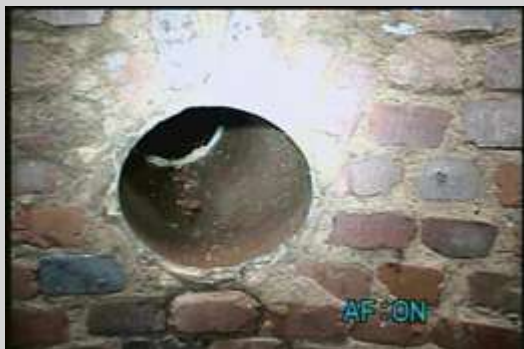
3 O'Clock Inflow

8 in. Circular Gravity Sewer
Pipe In @ 3 O'Clock

Invert Depth: **6.07** (ft.) Flow Characteristics: **Fast**

Infiltration: **None** Pipe Seal Cond: **Unknown**

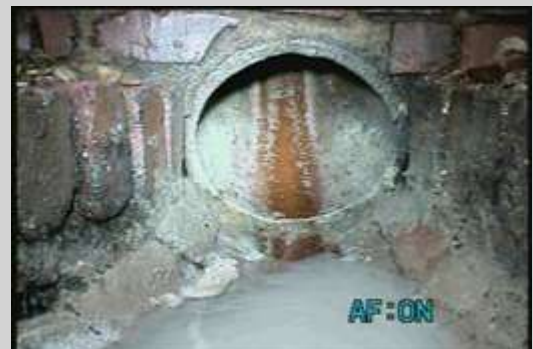
Drop In @ 3 O'Clock

Drop: **Outside Direct**

Inv Depth: **9.02** (ft.)

Drop Condition: **Open**

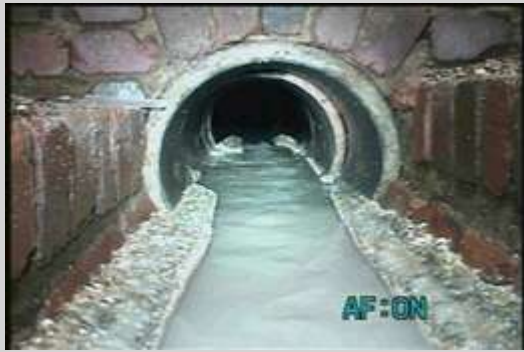
6 O'Clock Inflow

10 in. Circular Gravity Sewer
Pipe In @ 6 O'Clock

Invert Depth: **9.15** (ft.) Flow Characteristics: **Fast**

Infiltration: **None** Pipe Seal Cond: **Unknown**
